Chlorine Leakage from Control Valve in Charging Station Pipeline: A Case Study

Abstract

This paper describes accidental release of chlorine gas from control valve through a chlorine charging system in a green color pigment manufacturing chemical industry. The chlorine gas dispersed over the entire reactor floor and nearby area at night time shift work. This paper presents root cause analysis of the incident. Corrective and preventive measures are also discussed. Finally, conclusions reached with recommendations are drawn for industrial facilities for handling and prevention of chlorine.

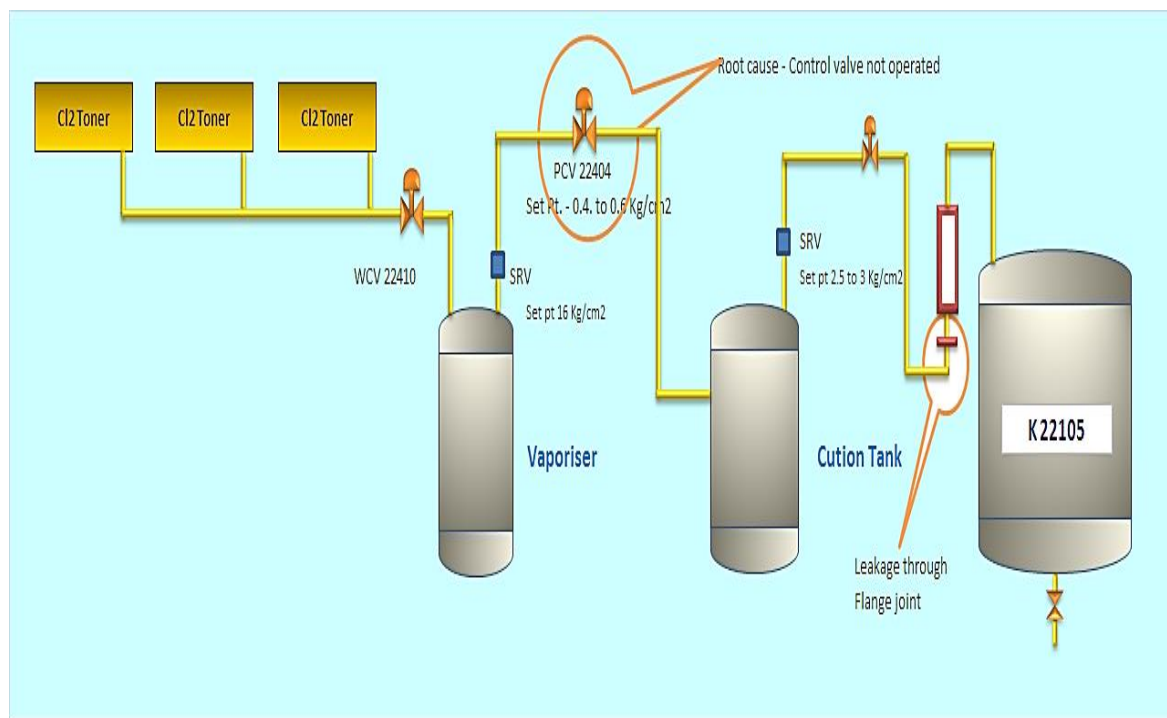
Fig. 1: General Setup.

PCV 22404 set at 0.4 to 0.6 kg/cm², which regulates the pressure of chlorine during drop test, failed and could not maintain the pressure between 0.4 and 0.6 kg/cm². The control valve was badly corroded and selected MOC of the control valve was not suitable.

1. Valve actuator got stuck and it remained in open condition due to which chlorine pressure could not be controlled.
2. Valve actuator wheel had some play and there was no lubrication of actuator so that it got stuck.
3. Preventive maintenance of control valve was not followed as per PM schedule.
4. Material of construction of the valve was not of suitable standard.

1. Prepare schedule for preventive maintenance of chlorine system on monthly basis (including control valve).
2. Proper selection of MOC for control valve with teflon coating inside the valve.
3. Provide secondary control in case of control valve failure.
4. Hazop and LOPA for the entire system will be revisited along with the team consisting of PE, Maintenance, Manufacturing, and Safety.
5. Alarm annunciator to be installed in SCADA room for extra alertness.
6. Provision of mechanical PRV and collection pot to be installed (these provisions are available in new Cl₂ charging system).

7. Maintain spare control valve for cushion tank to reduce MTTR.
8. Whole chlorine system to be checked by a competent person.
9. Calibration of safety relief valve on regular interval by competent authority.
10. Provide separate emergency scrubber system to take care of the worst case scenario for chlorine tonner area.
11. Provision of pressurized system for DCS room.
12. Fusible plug safety device on container should be tempered.
